Manhole Inspection Summary

Manhole # S37AA_023MH

Insp Date: **8/28/08 12:01 PM**

Location Address: **736 graves st**

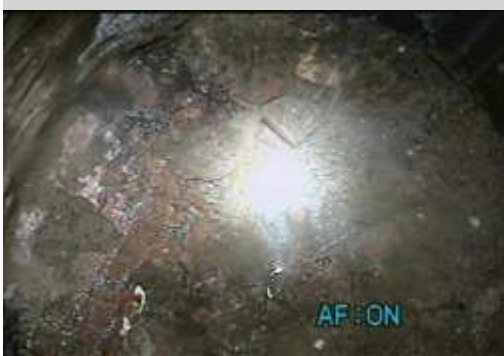
Defect 2

Condition: ☐ Sound ☐ Cracked ☐ Root Intrusion ☐ Deteriorated ☐ Leaks ☒ **Debris**

channel debris

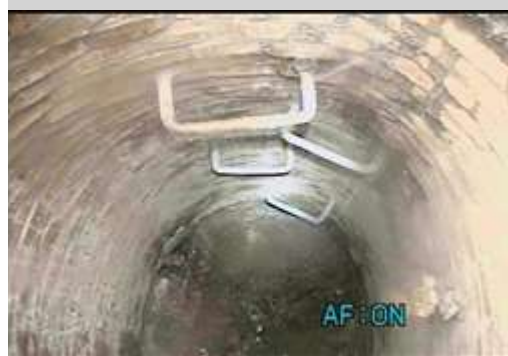
Defect 1

Count: **4** Missing: **0** ☒ **Corroded**

corroded steps

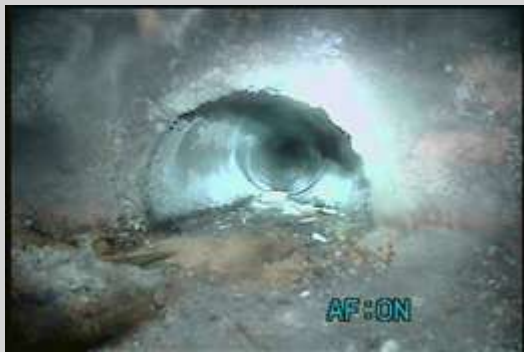
12 O'Clock Outflow

8 in. Circular Gravity Sewer
Pipe Out @ 12 O'Clock

Deposits: ☐ None ☐ Mud ☐ Sludge ☒ **Debris** ☐ Grease

Silt Depth: 1 (in.) Deposits Extent: **Light**
